# Districtwide Lead in Drinking Water Sampling and Remediation Plan

2023-2025

Greenport UFSD

Enviroscience Project #24262

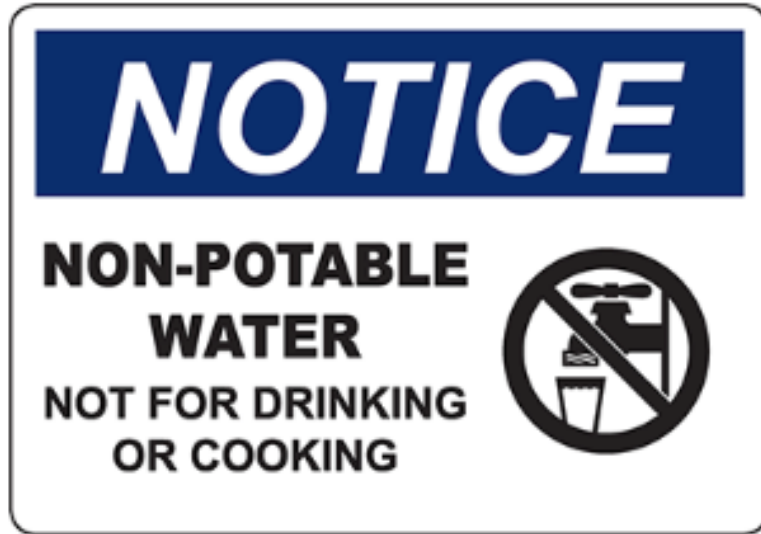
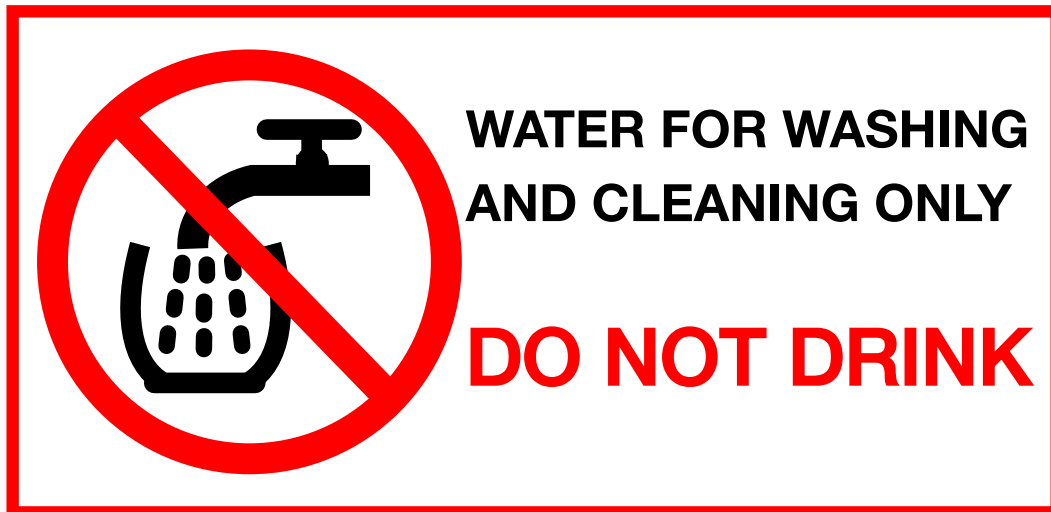
All locations deemed non-applicable, but do not have signs, should be taken offline until signs have been posted. Signs are suggested to have pictures that instruct for handwashing only, do not drink.
